**BROAD STREET  
OLD AND HISTORIC  
DISTRICT**  
RICHMOND, VIRGINIA

## **GUIDELINES AND STANDARDS**

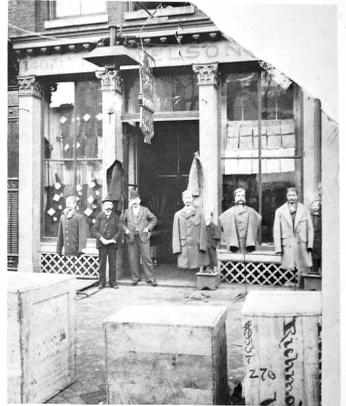
The term "frieze" is used here to identify the band of the facade which occurs above the storefront (see sketch below). This area is often defined by the pilasters which flank the storefront and the cornice at the bottom of the upper facade.

FRIEZE DETAILING

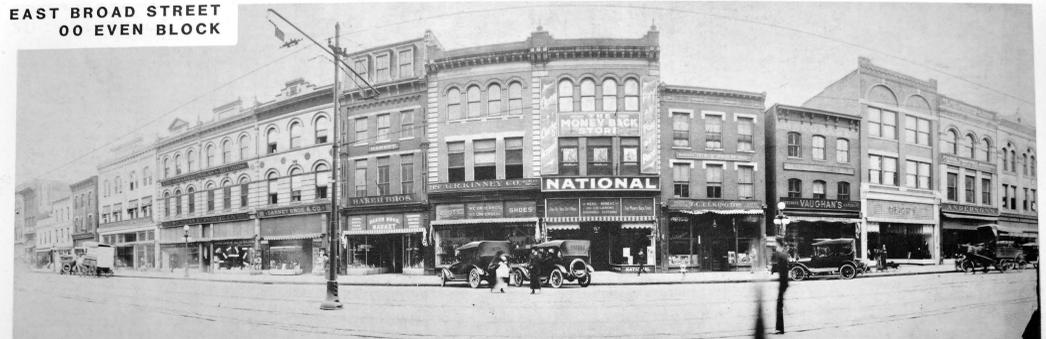
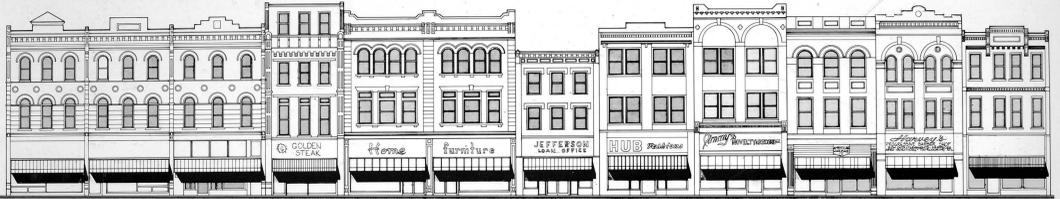
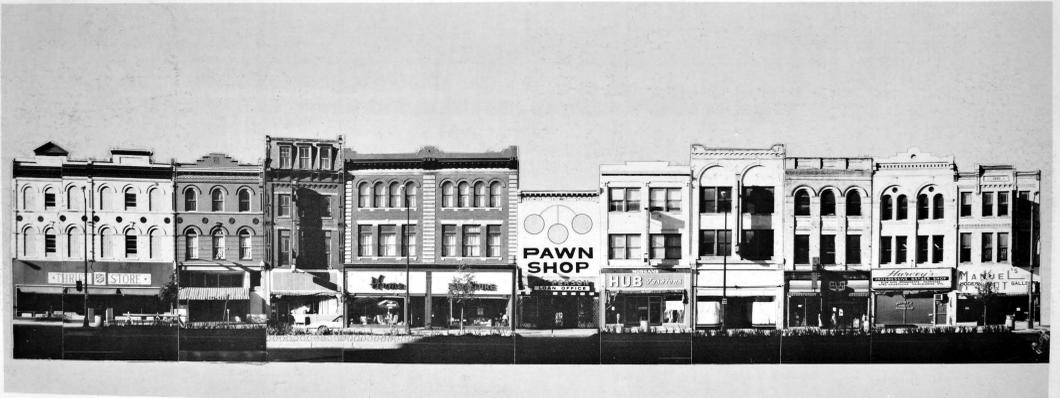
- |   |   |   |   |  |   |   |  |   |

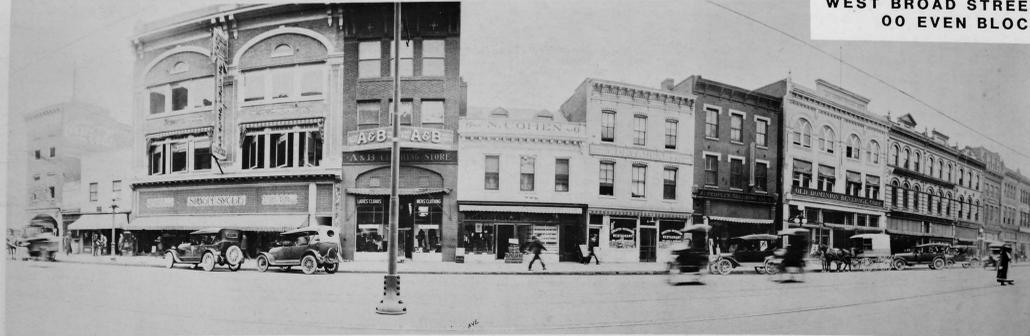
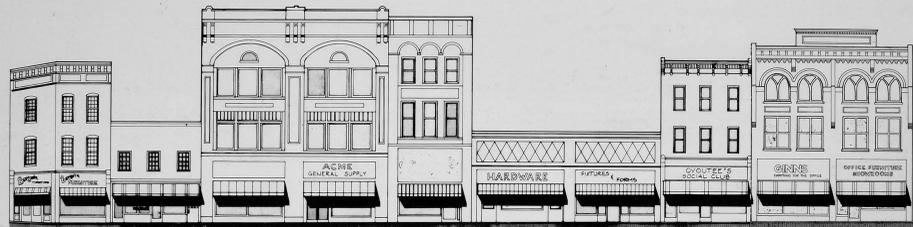
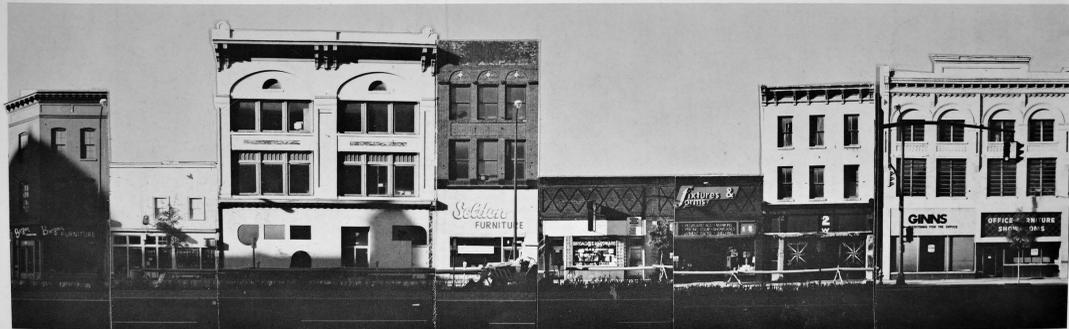
14 West Broad Street  
c. 1878

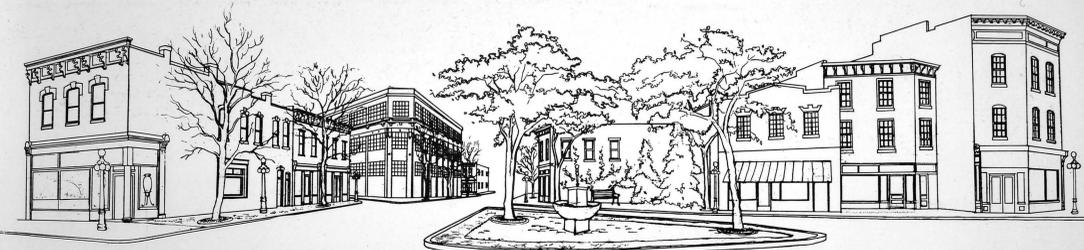
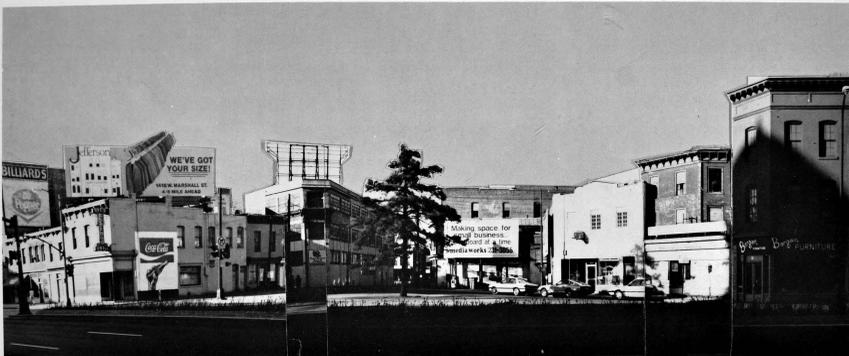
## 306-308 North Adams St.

## 310 North Adams Street

## 309 North Adams Street

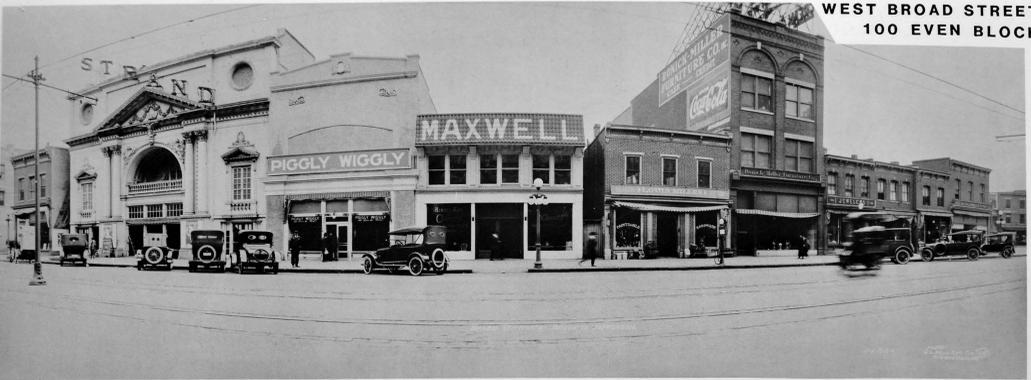
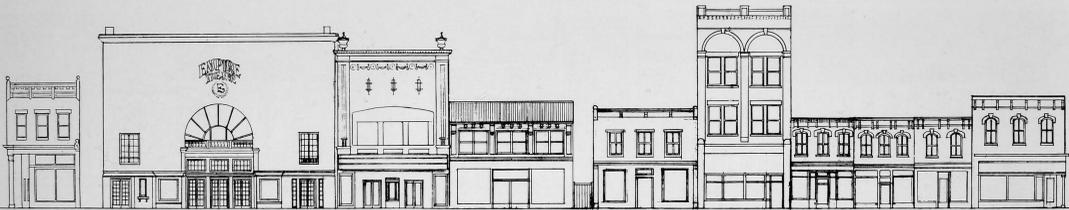
128 West Broad Street  
c. 1891

112 West Broad Street  
c. 1875

102 West Broad Street  
c. 1880

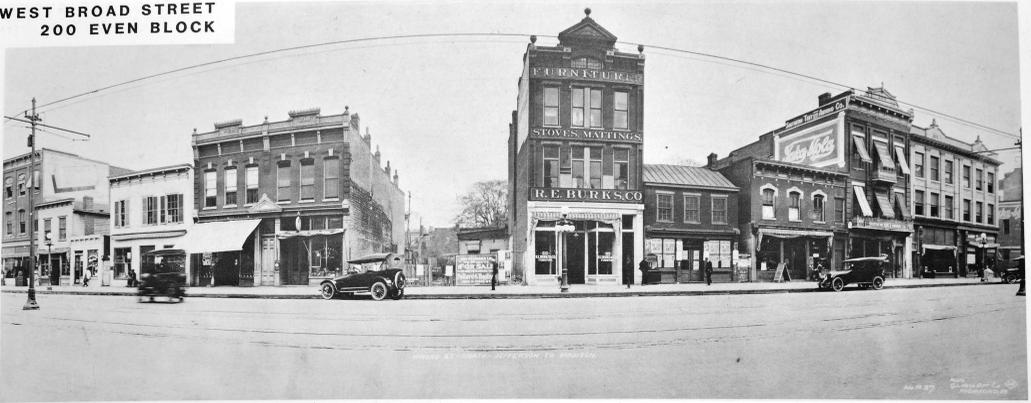
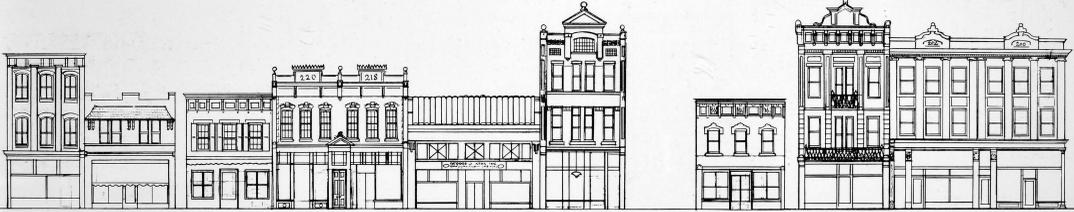
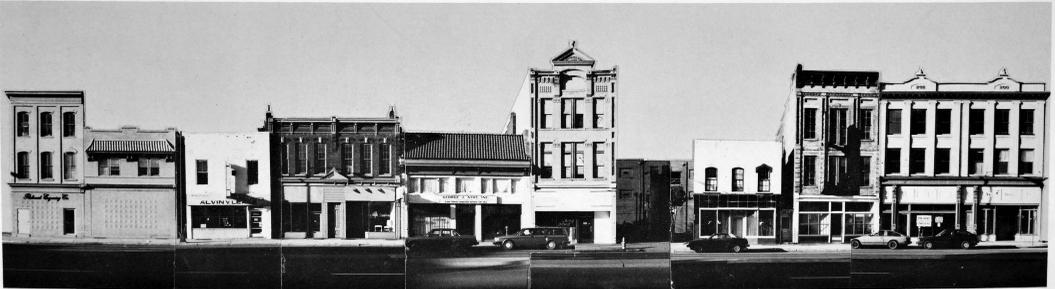
228 West Broad Street  
c. 1900

222 West Broad Street  
c. 1857

218-220 West Broad St.  
c. 1890

212 West Broad Street  
c. 1892

200-202 West Broad St.  
c. 1910

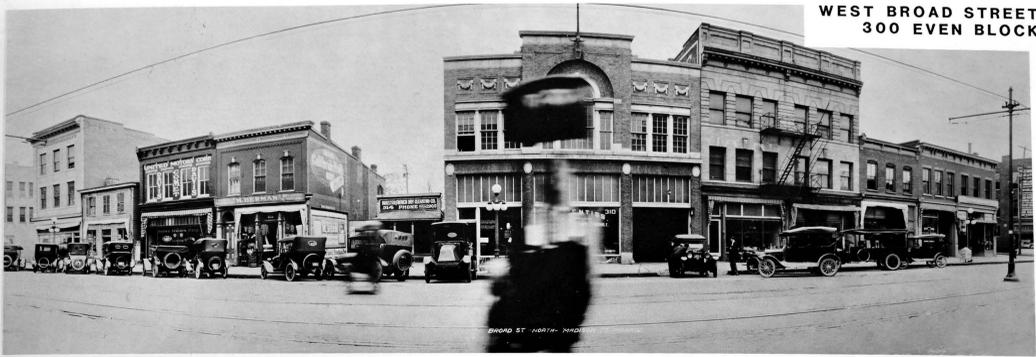
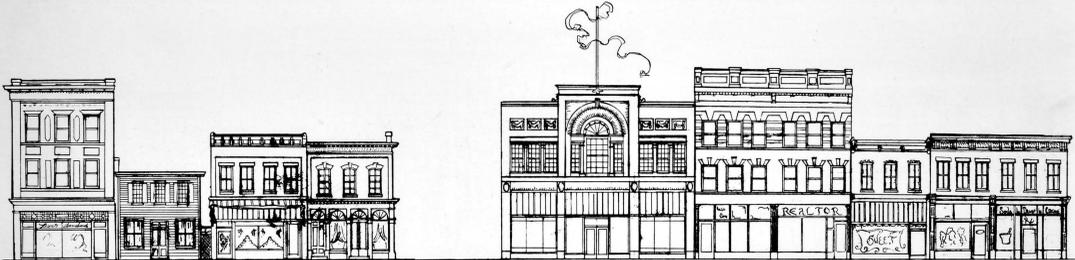
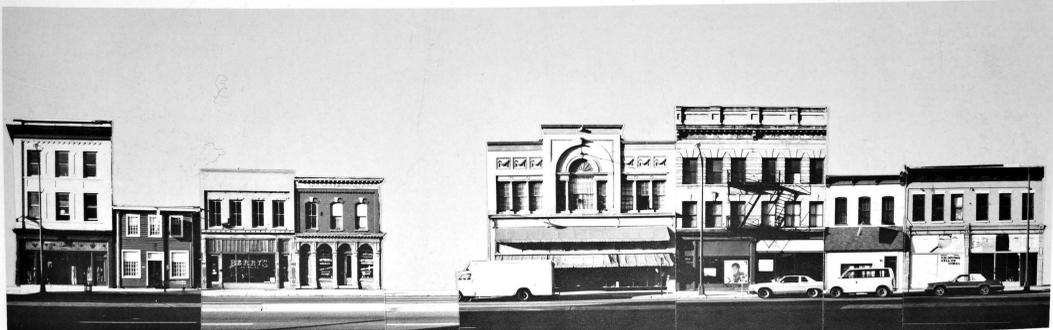
This handsome pair of important buildings has recently had an excellent restoration. The possibilities inherent in the whole district are on display here.

322 West Broad Street  
c. 1905  
This building's variety of recessed panels and dignified scale of window sashes are accentuated by its recent refurbishing. It is a simple, handsome example of the very many Broad Street buildings which look well treated with care and good taste.

318 West Broad Street  
c. 1880  
This structure's charm would return with the restoration of its cornice. Its storefront is largely original and restored extensively, but the small-paned windows are inappropriate. With an imaginative and appropriate paint scheme, the building should be quite interesting.

310 West Broad Street  
1916  
This flamboyant building, erected as an automobile showroom, has elaborate architectural detail. It is well-maintained, but the dark colors would be more appropriate. The Palladian window and awning cornice a Deauville touch to the district. The fascia should be utilized.

304 West Broad Street  
c. 1880  
The old panorama offers a good view of the chain of the original small store and the current pent roof and storefront are unfortunate changes to this building. They need to be removed and something closer to the earlier form erected.

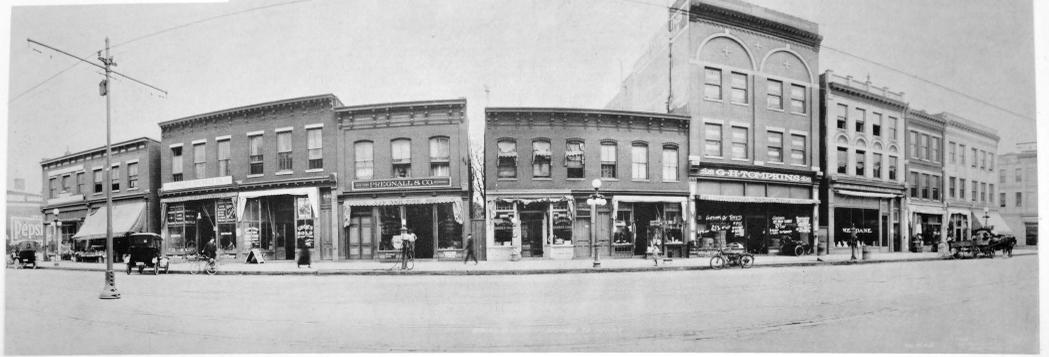
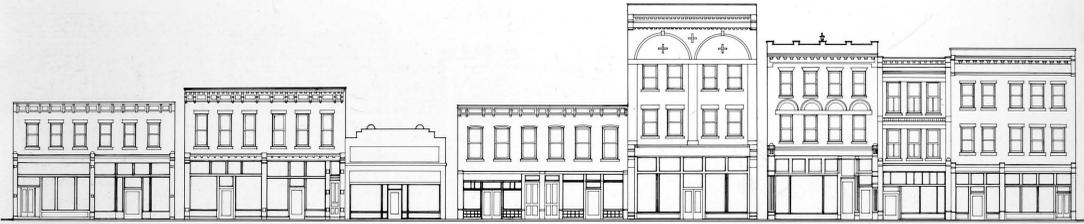
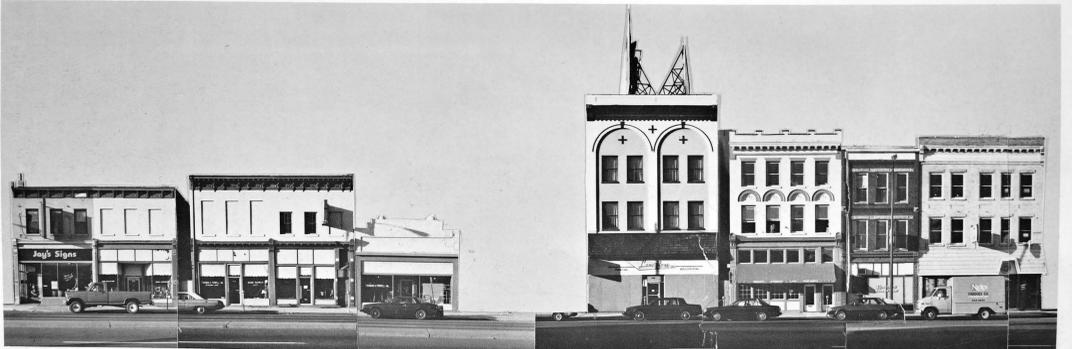
300-302 West Broad St.  
c. 1880  
The simple architectural detail on this building is appropriate for small commercial structures. The cast iron frame for the storefront survives and should be used to better advantage on the first floor with more fitting signs and window treatments.

420-422 West Broad St.  
c. 1880  
These two Italianate commercial buildings have been altered very little. They need coordinated paint, details, and signs confined to the second floor. Signs directly above the storefronts, with these improvements, these signs could visually draw those on the next block west into the district. The recessed entrances and depth to the facade, which is then applied by the visual appearance of the closed windows.

414 West Broad Street  
c. 1930  
This building's "modern" parapet has great geometry. The sign needs to be placed in one of the recessed panels. If the building were painted in an interesting scheme, the facade would realize its full potential.

410-412 W. Broad Street  
The double building that originally stood on this empty lot has been replaced in the architect's drawing. Reconstructing a missing building would permit the recommended solution when infill is needed.

404 West Broad Street  
c. 1900  
This charming building needs only to be cleaned to do justice to its granite trim. If the upper section of the storefront were painted a dark color, it would not stand out as the perpendicular sign should be removed.

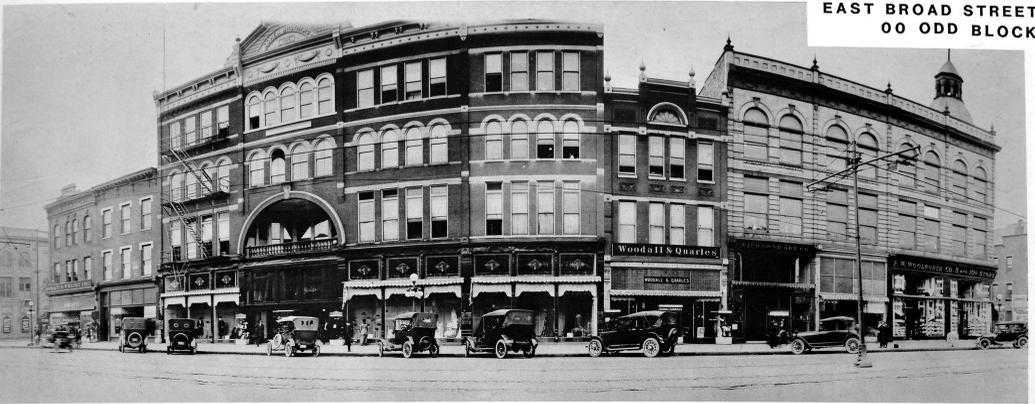
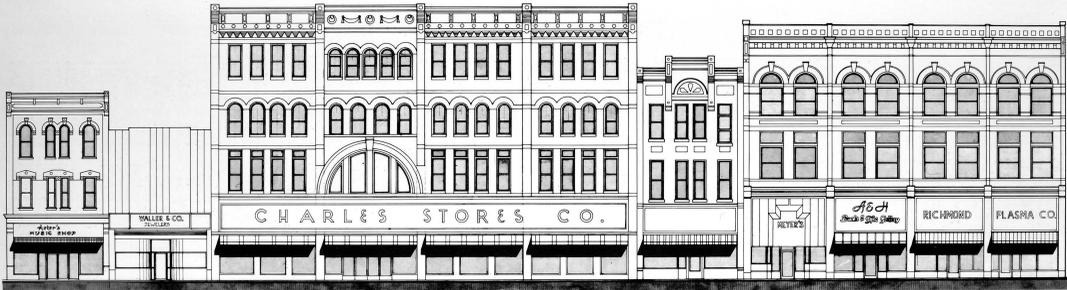
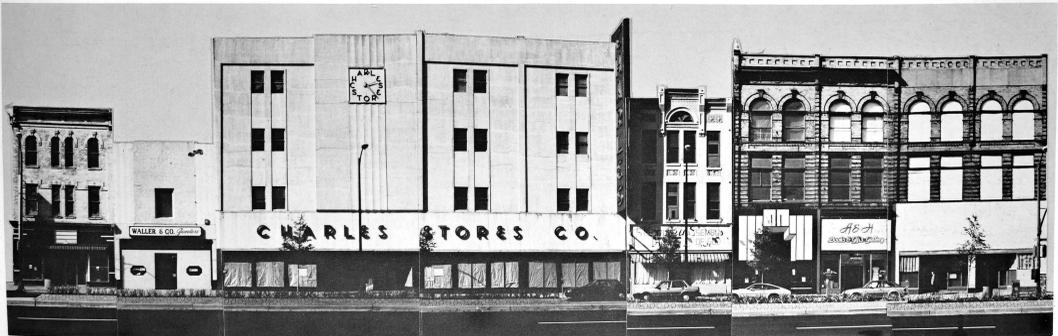
21 East Broad Street  
c. 1880; remodelled 1936  
Variety in the placement  
of the windows and their  
shades adds interest  
to this building. The signs  
point to the windows, and  
an imaginative painter  
scheme would enliven  
the whole corner. The  
victorian storefront  
could stay or one more  
appropriate to the  
upper floors could re-  
place it. Leaded glass  
continued the original  
storefront seen in old  
photographs.

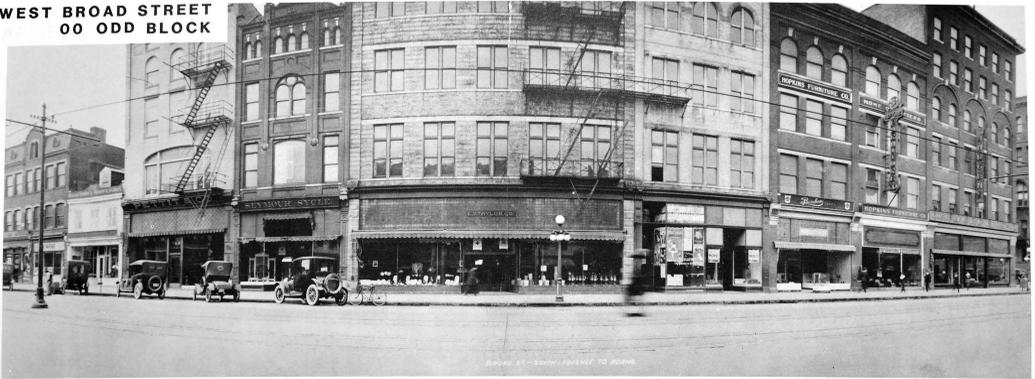
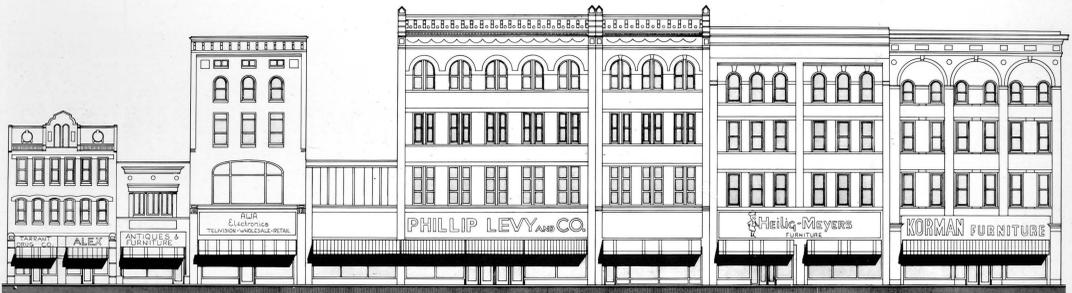
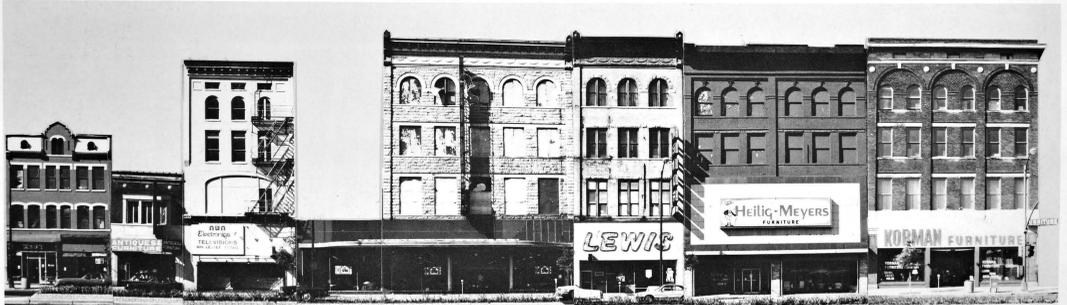
This row would form a  
strong corner if the  
brick were cleaned, the  
storefronts of 1, 3,  
and 5 were redesigned,  
and the existing por-  
ches and finials were  
restored. These build-  
ings show well how time  
and style have influ-  
enced Broad Street.

1-3 West Broad Street  
c. 1880

11-17 West Broad Street  
1898

23-25 West Broad Street  
1910

27 West Broad Street  
c. 1910

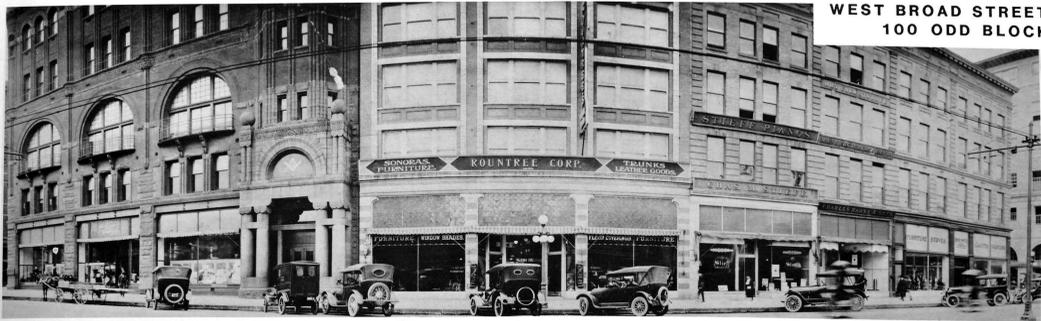
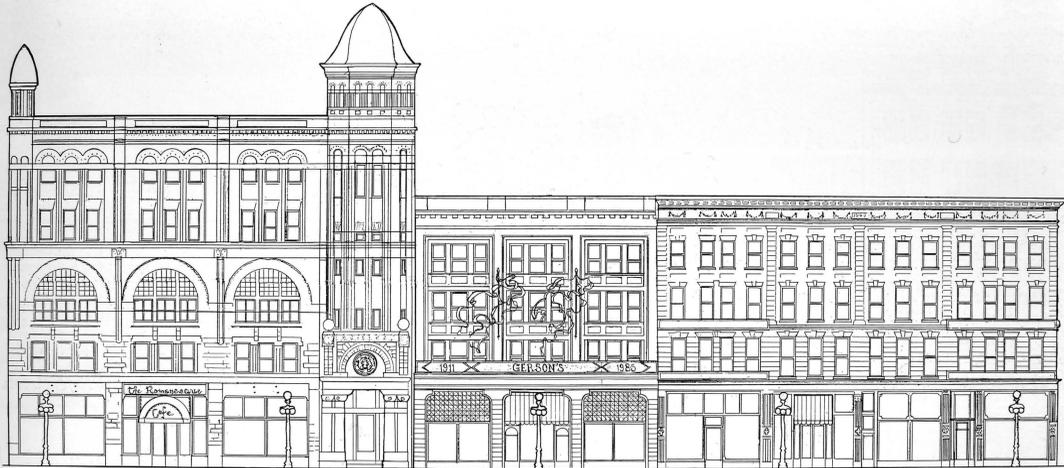
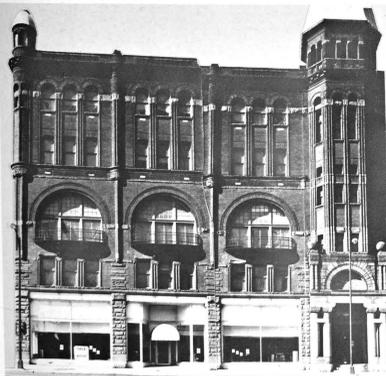
101 West Broad Street  
1888

at the time. The building's design is complex but expressive. Major rooms - the auditorium and the ballrooms - are indicated by large arched openings. These rooms have small windows because it would form a composition of the entrance with paired columns and a massive

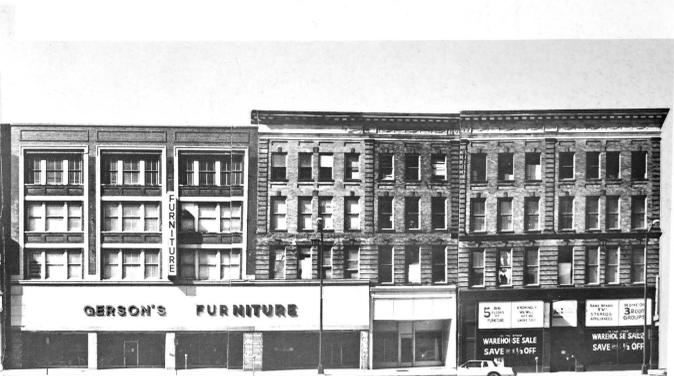
113 West Broad Street  
1911

"Modern" architecture first appeared in Richmond in commercial structures such as this one. The very restricted use of classical ornament, such as the pediment supported by molding at the cornice line, combined with the large three-part windows made an

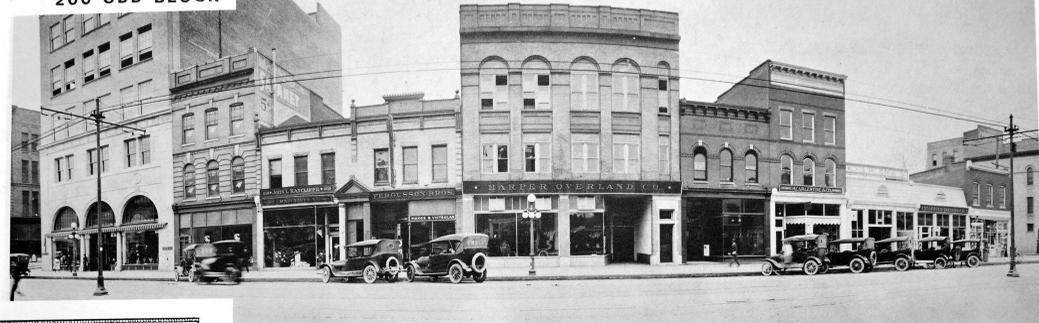
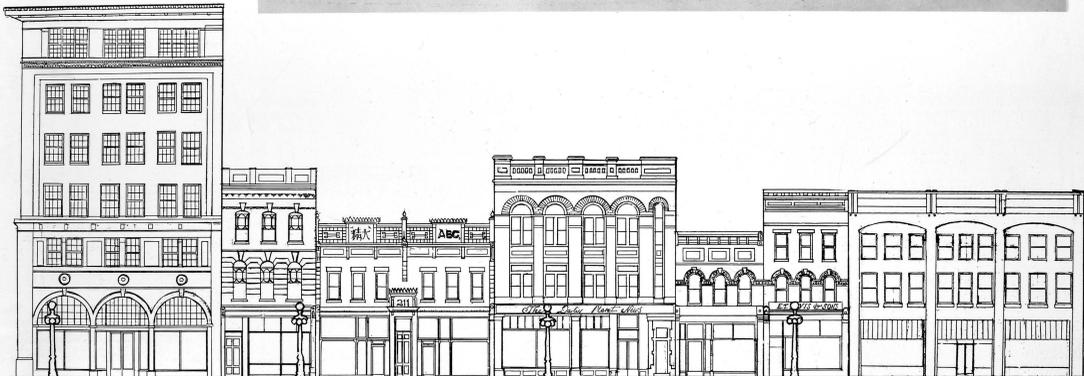
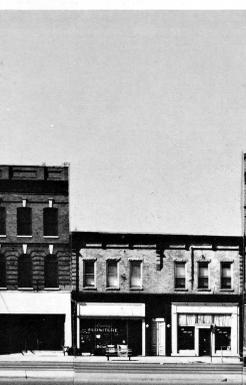
ing. These dignified buildings would form a most sophisticated corner. Restoration of the missing elements and reworking all of the details would result in one of the most impressive commercial buildings in the city.

207 West Broad Street  
c. 1903  
The parapet on the roof, the contrasting keytones over the windows and the rusticated brick on the second floor all contribute to this building's understated dignity. The brick should be cleaned and the storefront repaired to be more in keeping with the upper floors.

221-225 West Broad St.  
c. 1860  
These modern storefronts continue the scale of the others on the block and the sign is also appropriately sized. Unfortunately, the height of the building itself is very distracting. If this building could be enclosed in a larger one, or ornamented with a false front, it could make a major contribution to the character of the neighborhood.

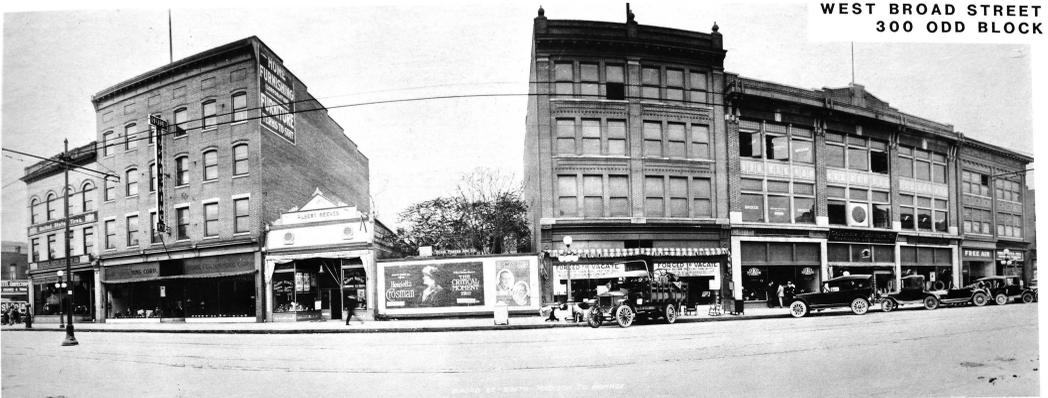
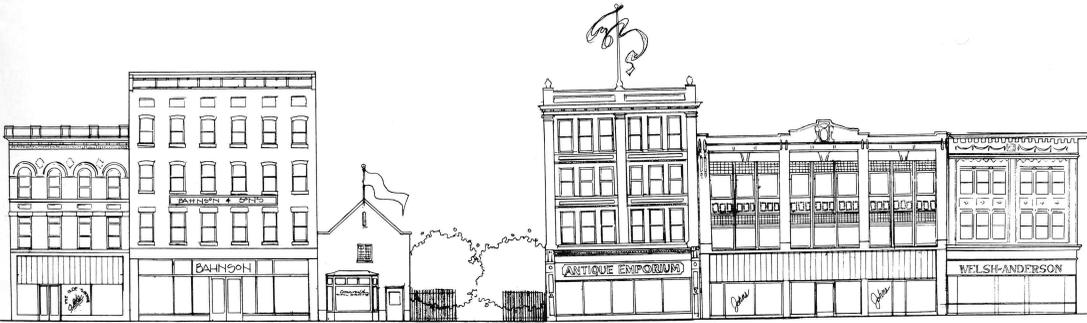
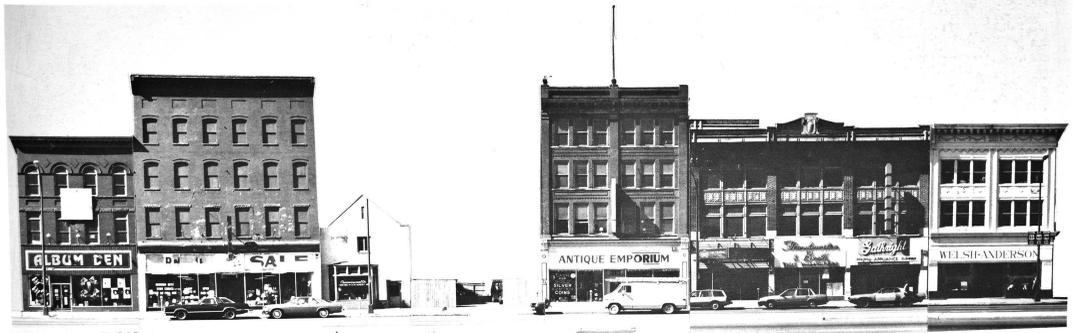
301-303 West Broad St.  
c. 1890

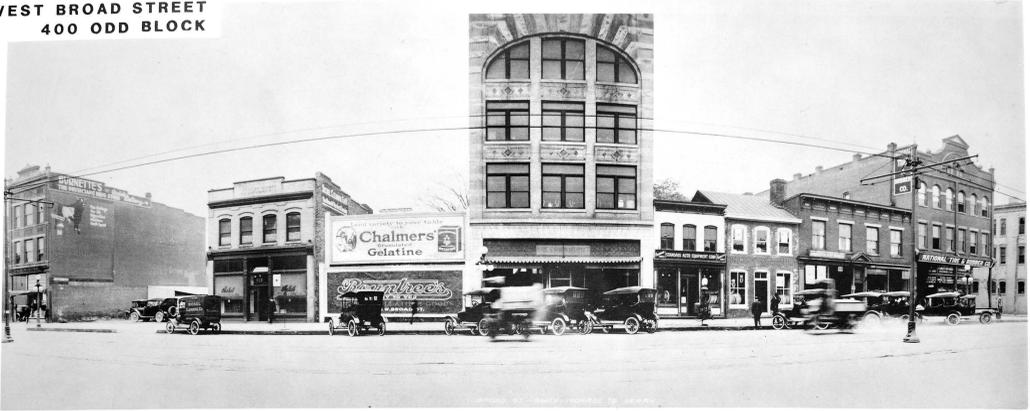
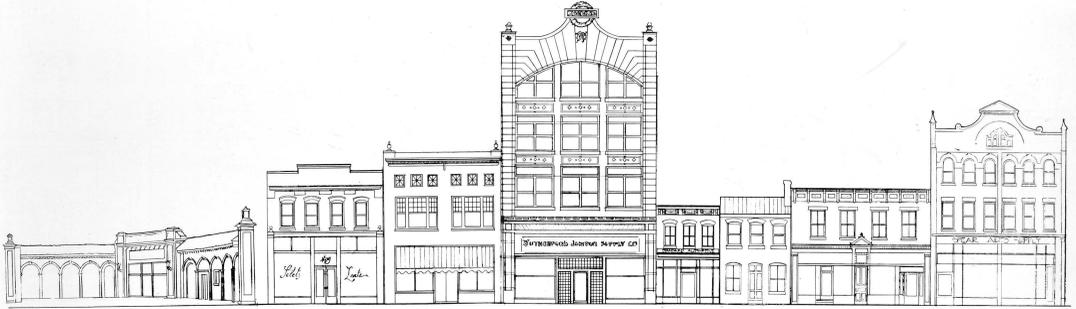
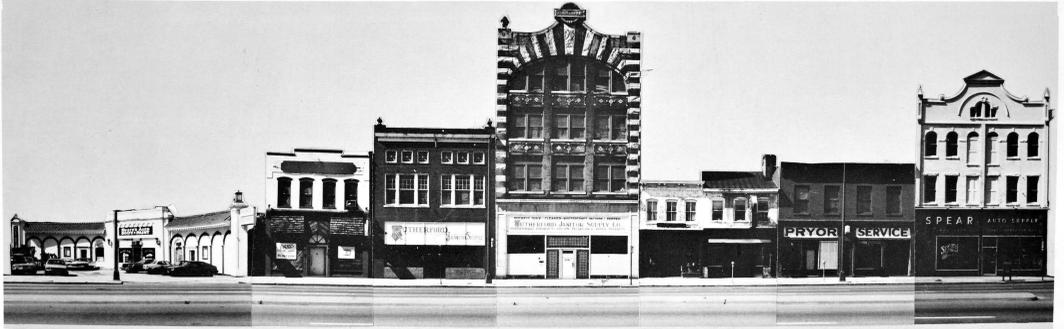
401-407 West Broad St.  
c. 1926

425-427 West Broad St.  
c. 1906
